re: Investigation and Sampling of Drinking Water for Lead Concentrations

**Investigation and Sampling
Of Sources of Potable Water
For Lead Concentrations**

Conditions as of October 1, 2016

- Drake Elementary School, 388 Drake Drive, North Tonawanda, NY

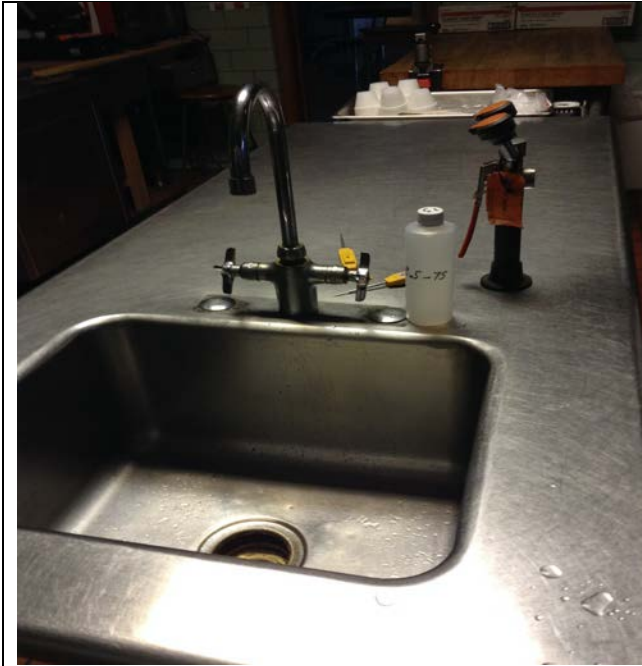
View of Kitchen Sink Location, Sample #:
448.5-75

For outlets analyzed with a lead concentration in excess of the NYS Action Level, regulations require:

- (a) Prohibit use of the outlet until:
 - (1) a lead remediation plan is implemented to mitigate the lead level of such outlet; and
 - (2) test results indicate that the lead levels are at or below the action level;
- (b) provide building occupants with an adequate supply of potable water for drinking and cooking until remediation is performed;
- (c) report the test results to the local health department as soon as practicable, but no more than 1 business day after the school received the laboratory report; and
- (d) notify all staff and all persons in parental relation to students of the test results, in writing, as soon as practicable but no more than 10 business days after the school received the laboratory report.

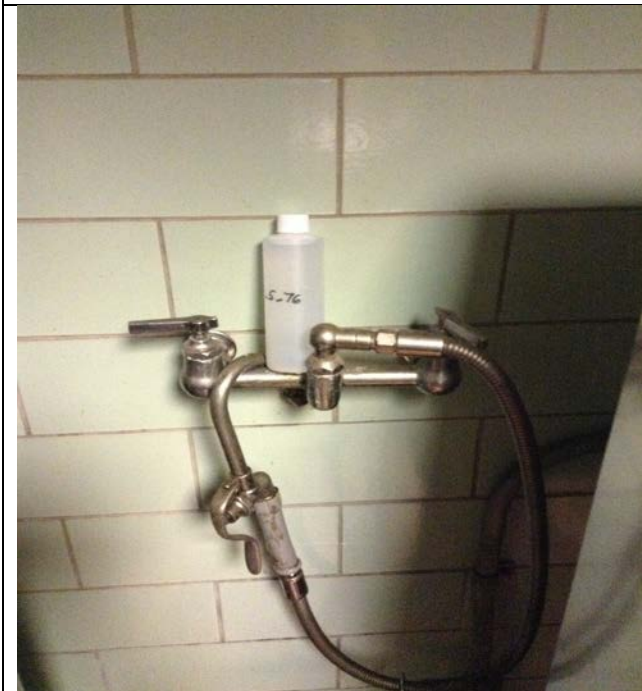
View of Kitchen Spigot Location, Sample #:
448.5-76
